MEMORANDUM

DATE: 12/19/2018
SUBJECT: Kenwood Road & Sycamore Plaza U-Turns
PREPARED BY: TEC Engineering, Inc.
PREPARED FOR: Sycamore Township

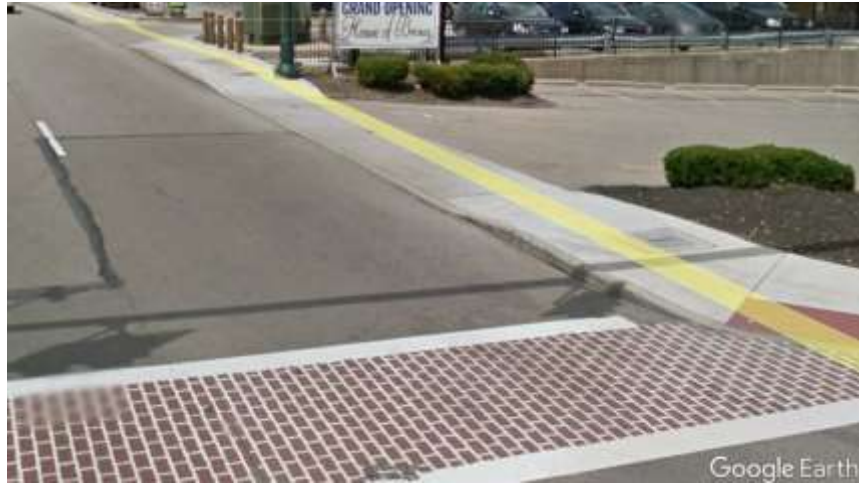
2015 Google Street View

Surrounding the intersection, the pavement, pavement markings, signs, and traffic signals are all in above average condition and clearly visible. The curb along Kenwood Road on the northeast corner of the intersection has clearly visible tire scuff marks, likely from southbound U-turn vehicles, based on the angle of the markings. The markings are present in Google Street View images from 2015-2018 as shown below.
